Manhole Inspection Summary

Manhole # S37W1_039MH

Insp Date: **5/5/08 2:27 PM**

Location Address: **3724 S Hanover St.**

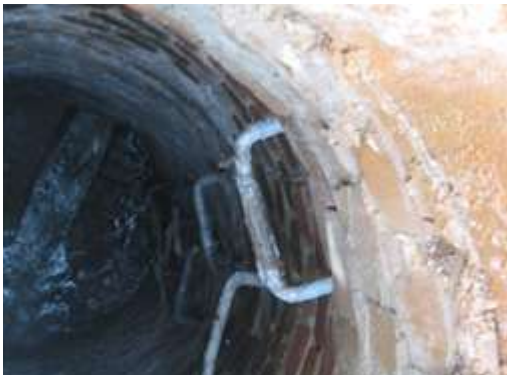
Steps

Count: **7** Missing: **0** ☒ **Corroded**

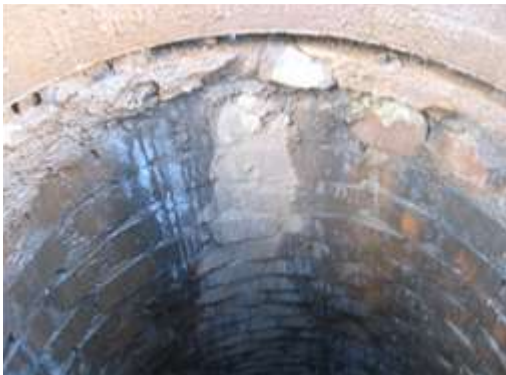
Defect 1

Condition: ☐ Sound ☒ **Cracked** ☐ Root Intrusion ☐ Loose Brick ☐ Deteriorated

Infiltration: ☐ None ☒ **Joint** ☒ **Cracks** ☐ Mortar ☐ Roots ☐ Wall

Joint

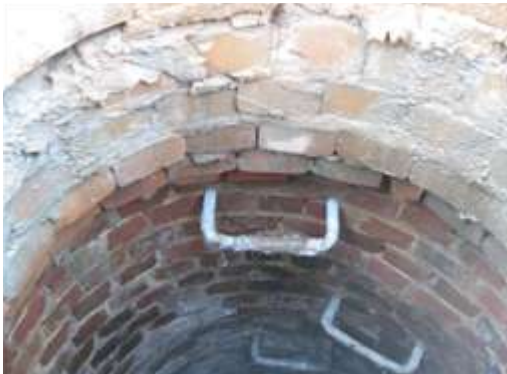
Defect 2

Infiltration: ☐ None ☐ Joint ☐ Cracks ☐ Mortar ☐ Roots ☒ **Wall**

Wall

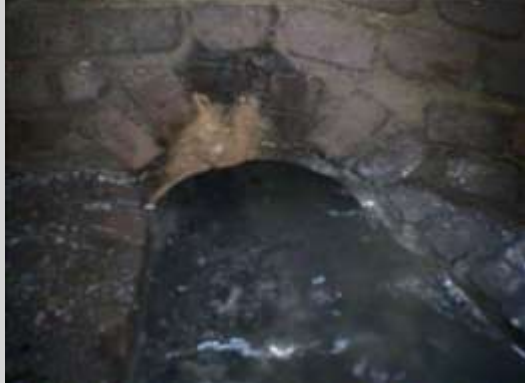
12 O'Clock Outflow

12 in. Circular Gravity Sewer
Pipe Out @ 12 O'Clock

Pipe Height: **9.6** (in.) Rod and Bar (Angled)
Pipe Material: **Clay** ☐ Pipe Lined
Invert Depth: **11.84** (ft.) Flow Characteristics: **Fast**
Deposits: ☐ None ☒ Mud ☒ Sludge ☐ Debris ☐ Grease
Silt Depth: **3** (in.) Deposits Extent: **Medium**
Infiltration: **None** Pipe Seal Cond: **Sound**

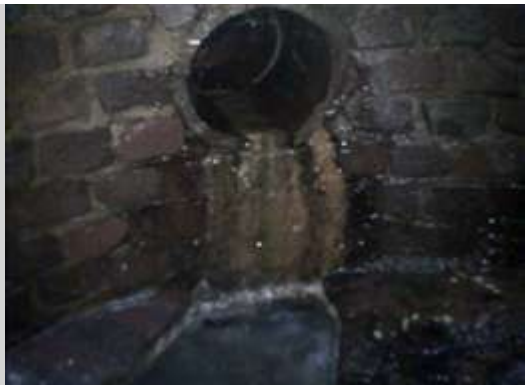
5 O'Clock Inflow

10 in. Circular Service Sewer
Pipe In @ 5 O'Clock

Pipe Height: **9.6** (in.) Rod and Bar (Angled)
Pipe Material: **Clay** ☐ Pipe Lined
Invert Depth: **10.54** (ft.) Flow Characteristics: **Fast**
Deposits: ☒ None ☐ Mud ☐ Sludge ☐ Debris ☐ Grease
Silt Depth: (in.) Deposits Extent:
Infiltration: **None** Pipe Seal Cond: **Sound**

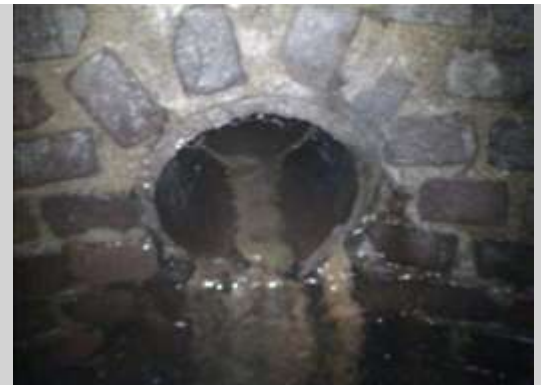
Pipe In @ 5 O'Clock

Drop: **Outside** Rod and Bar
Angled: **Yes** Reading: **11.01** (ft.)
Inv Depth: **12.01** (ft.)

Drop Condition: **Partly Clogged**

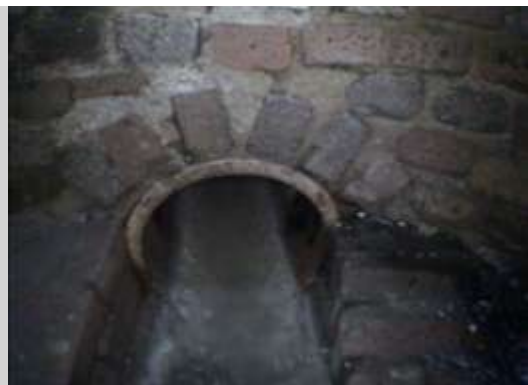
8 O'Clock Inflow

10 in. Circular Gravity Sewer
Pipe In @ 8 O'Clock

Pipe Height: **10.8** (in.) Rod and Bar (Angled)

Infiltration: **None** Pipe Seal Cond: **Sound**
